*Performance of the  
St. Marys River ice booms, 1976-1977*

Roscoe E. Perham

Sept [REDACTED] 1978

Prepared for  
U.S. ARMY ENGINEER DISTRICT  
DETROIT, MICHIGAN

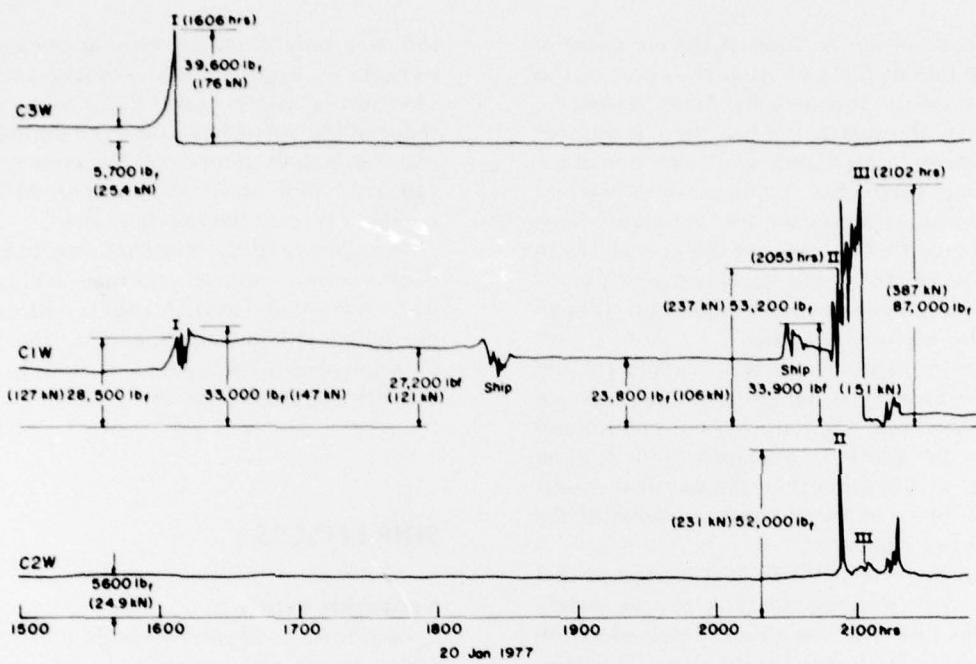
Figure 2. Copy of signal traces, 20 January 1977.

The peak force level of 52,000 lb (231 kN) in C2W at 2053 hours seems to indicate the time that C3W' broke. However, a similar peak of 87,000 lb (387 kN) that developed in C1W at 2102 hours could have been related to the shore anchor break except that it happened at a different time. The log book gives the time for "a loud noise" associated with the breaking of the structure as 2050 hours. Assuming that the shore anchor broke at 2050 hours, the ice could start moving and cause C3W' to break at 2053 hours as indicated by C2W forces. This indicates, therefore, that the anchor chain was the second item to break.

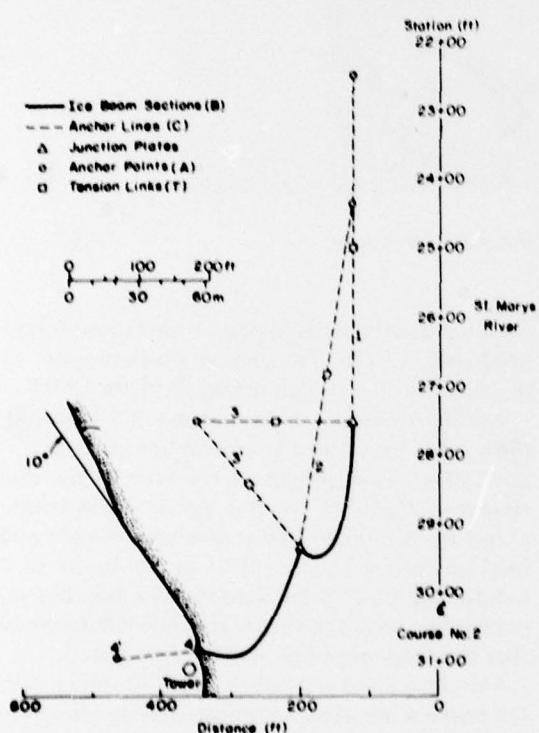
At the A4W anchor point the load is carried by a stud link chain of 1½-in. (4.4-cm)-diam stock. One of the links broke in two places. The larger remaining section was found to have a slight lateral bend of about  $\frac{1}{16}$  in. (0.5 cm).

**Figure 4. Plan of west ice boom.**

The fourth item found broken was a minor connector, an attachment plate on the timber nearest shore. The plate was torn off laterally probably by the B2W ice boom cable undergoing load release movements after the anchor's chain broke.

as C1W (Fig. 4). There was a pronounced change in the force level of C1W as a result of this event. Since the other two anchor line assemblies that broke were not instrumented, it is difficult to say when they failed. However, one of them, C3W', shared a junction plate with the instrumented line C2W and, if the force in C3W' changed substantially, it could be expected that this would affect the signal level in C2W.

3. Check parts carefully for weakening due to wearing, fatigue, or sharp indentations. Replace all broken parts and components of questionable strength before reinstalling them.
